# EMBANKMENT SLOPE STABILIZATION USING SUBHORIZONTAL DRAINS AT HIGHWAY 39 NEAR DRAYTON VALLEY, ALBERTA

This paper describes a case history including the results of a geotechnical investigation and design measures to remediate a slide area affecting a section of Highway 39:06, km 12.6, located east of the town of Drayton Valley, Alberta.

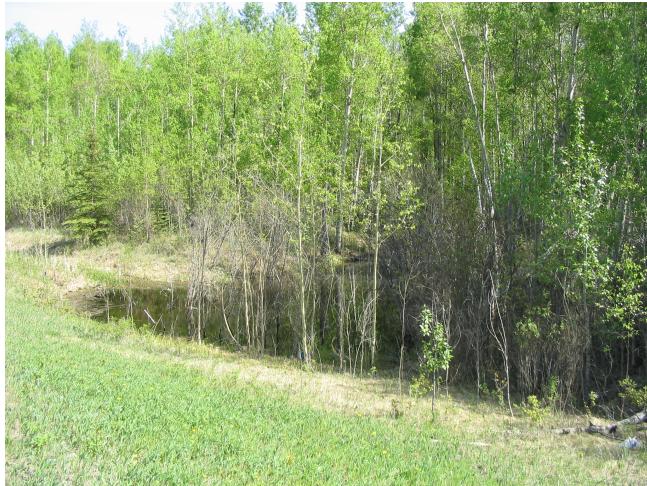
An 800 mm diameter centreline culvert was blocked, probably because of the slide, which caused water to pond in a low area adjacent to the uphill ditch. The pooled water was a continuous source of local groundwater recharge. Figures 1 and 2 show the site conditions.

Figure 1. Pooled water in south ditch at blocked culvert location.

The upslope pond formed by the centreline culvert blockage was a source of groundwater recharge. A new centreline culvert was considered most suitable for maintaining the upslope area dry. In addition to the pond dewatering, the following remediation options were considered to increase the factor of safety against slope failure:

The remediation work for this site started on May 3, 2005 with the installation of the subhorizontal drains. The construction was completed on June 14, 2005. The centreline culvert installation work for the dewatering of the upslope pond started on October 3, 2005 and was completed on October 24, 2005. A 750 mm diameter smooth wall steel pipe was pushed through the embankment and the uphill area was contoured to provide drainage to the new pipe.

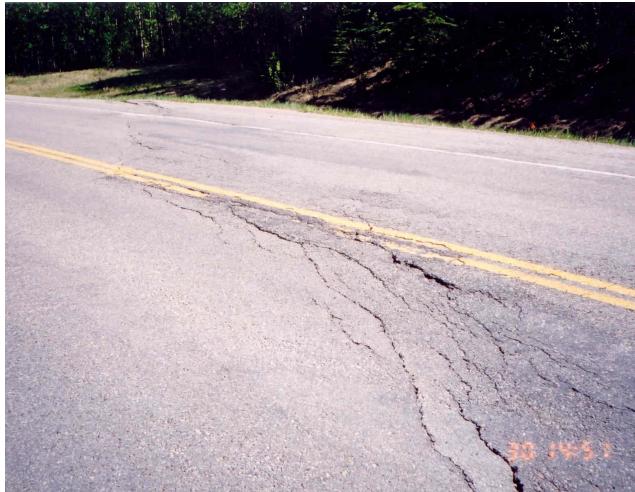
According to Swan (2002), the first distress on the roadway surface was noted around 1978-79. The distressed area was patched twice yearly until the early 1980's. In 1982-84 a trench drain about 100 m long and 2 m deep was installed within the uphill ditch adjacent to the distressed area, and a trench drain was also installed crossing the highway. These efforts reduced the patching rate to about once every other year. With time, the patching rate increased to yearly.

Figure 2. Pavement distress, west flank of the slide, looking southeast.

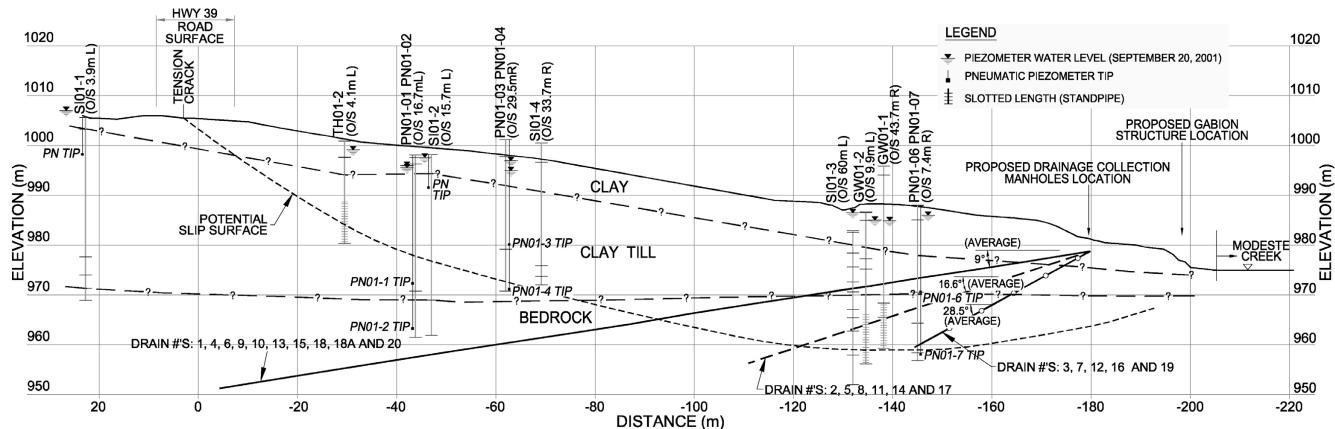
Figure 3 shows a cross section through the centre of the slide with the soil stratigraphy and inferred shear plane based on the depth of movement recorded in the SIs.

Stability analyses were carried out using the limit equilibrium software GSlope. A back analysis indicated that the instability is primarily driven by high pore pressures, with artesian or near-artesian conditions occurring over the lower third of the slope. The back analysis also indicated that the bedrock was likely pre-sheared; and the shear strength of this material was likely near or at residual strength. Toe erosion at creek level was not found to be a significant factor in the slope stability. Additional stability analyses were performed to assess suitable remediation options to improve the slope factor of safety to a target of approximately 1.3.

Reducing the pore pressure by installing subhorizontal drains was considered to be the most cost effective remediation measure. The stability analyses showed that by lowering the groundwater level by about 5 m the slope FS would increase by approximately 30 %.

Figure 3. Cross section showing subsurface conditions, inferred shear plane, and subhorizontal drains.

The subhorizontal drain system consisted of two clusters of drains fanning vertically and horizontally as shown in Figures 3 and 4, respectively. Each drain cluster terminated in a drainage collection manhole consisting of a vertical corrugated steel pipe (CSP) culvert, 1.2 m in diameter, installed near the toe of the slope. Each manhole was

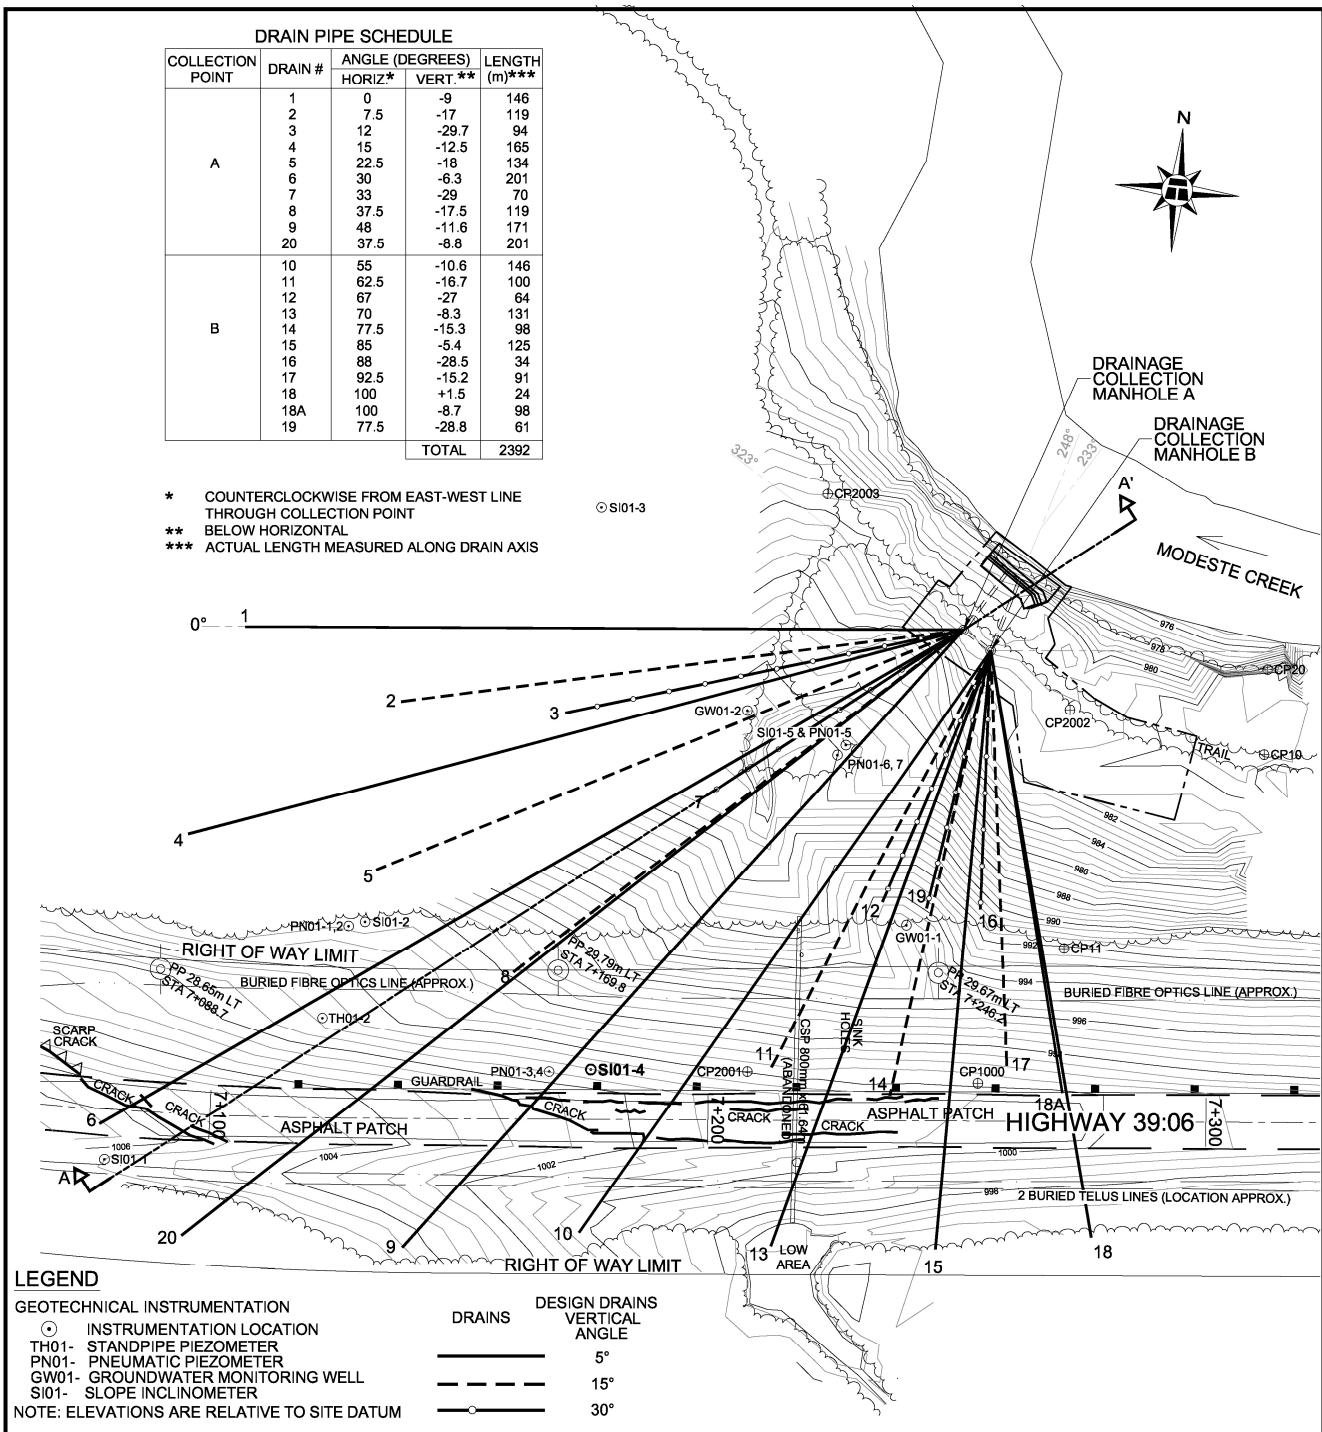
A total length of 2392 m of subhorizontal drains were installed, consisting of 21 drains with lengths varying from 24 m to 201 m. The drains consisted of 38 mm diameter schedule 80 PVC pipes, with 3 rows of 0.25 mm wide slots and 6.4 mm clear spacing between the slots within the rows. Each row of slots was centered at 120° intervals around the pipe circumference.

Figure 4. Site Plan showing subhorizontal drains layout.

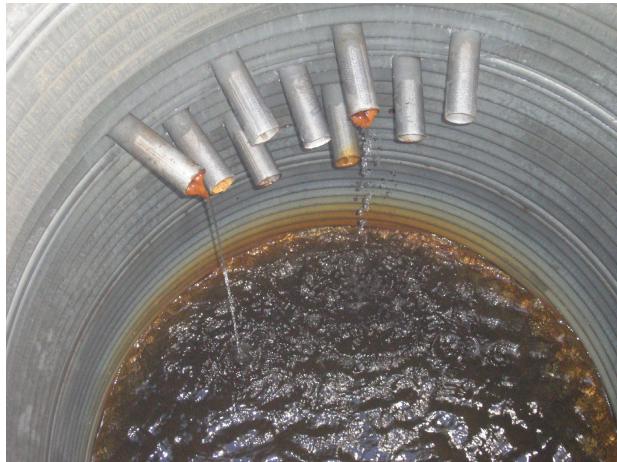
Since installation these two drains have continuously yielded water with a few others seasonally producing water. Figures 5 and 6 show a general view of the inside of the manhole and the gabion outfall, respectively.

Figure 5. Subhorizontal drain outlets.

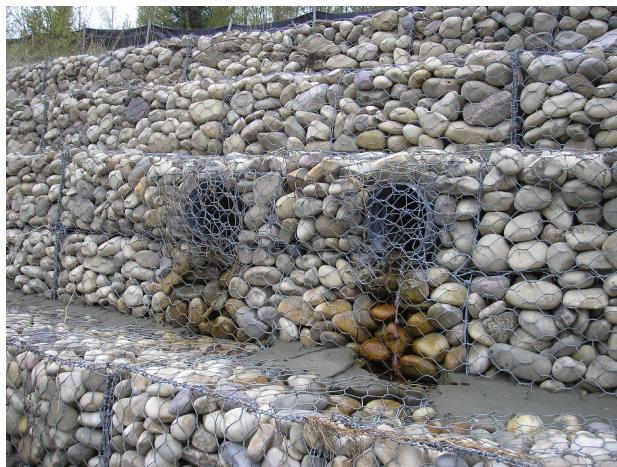
constructed with a 300 mm diameter CSP outlet pipe that drained the groundwater through a gabion outfall structure installed along the river bank. A cross-connection between the two manholes was built to allow for continued drainage in the case that one of the manhole outlets became clogged.

Figure 6. Manhole outlets in gabion outfall structure.

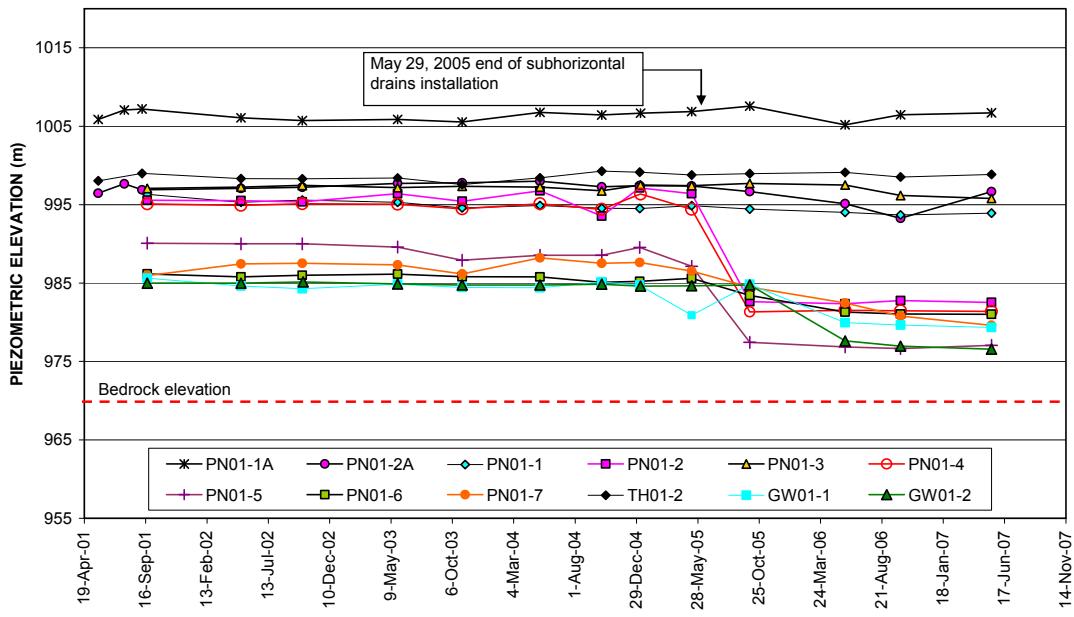
Figure 7 shows the results of the piezometer readings before and after the remediation work. Of the twelve piezometers installed, seven measured a significant drop in groundwater levels. Three piezometers (PN01-2, PN01-4 and PN01-5) showed a relatively fast (5 month) response in lowering the groundwater elevation, and the others show a more gradual response with time. Since the end of the subhorizontal drain installation (May 29, 2005) the recorded drop in groundwater elevation varied from 4.6 m to 13.8 m. No significant rebound in groundwater elevation has been noted in the last 2 years of monitoring. In fact, piezometers PN01-7 and GW01-2 continue to show a slow but continuous drop in groundwater elevation.

Figure 7. Piezometer readings before and after subhorizontal drains installation.

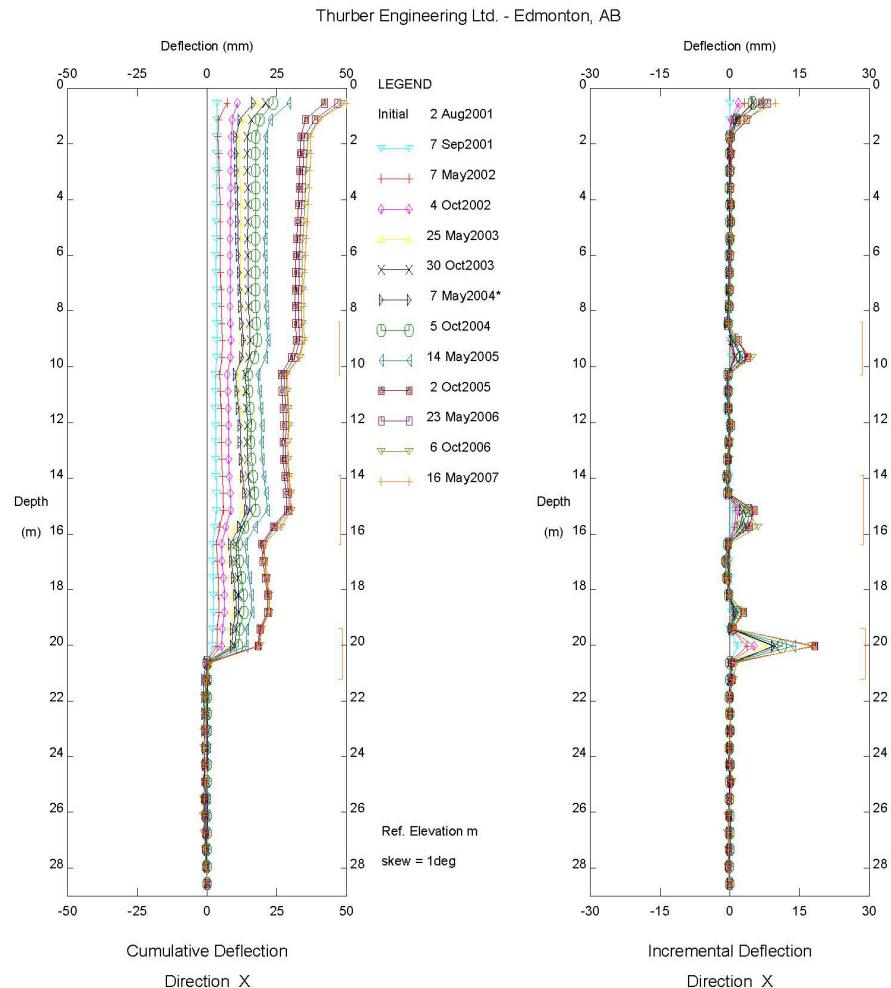
Figure 8 shows cumulative and incremental movement readings from one of the site slope inclinometers (SI01-4) and Figure 9 shows the rate of movement plot from the

Figure 8. Typical slope inclinometer (SI01-4) cumulative and incremental deflection.

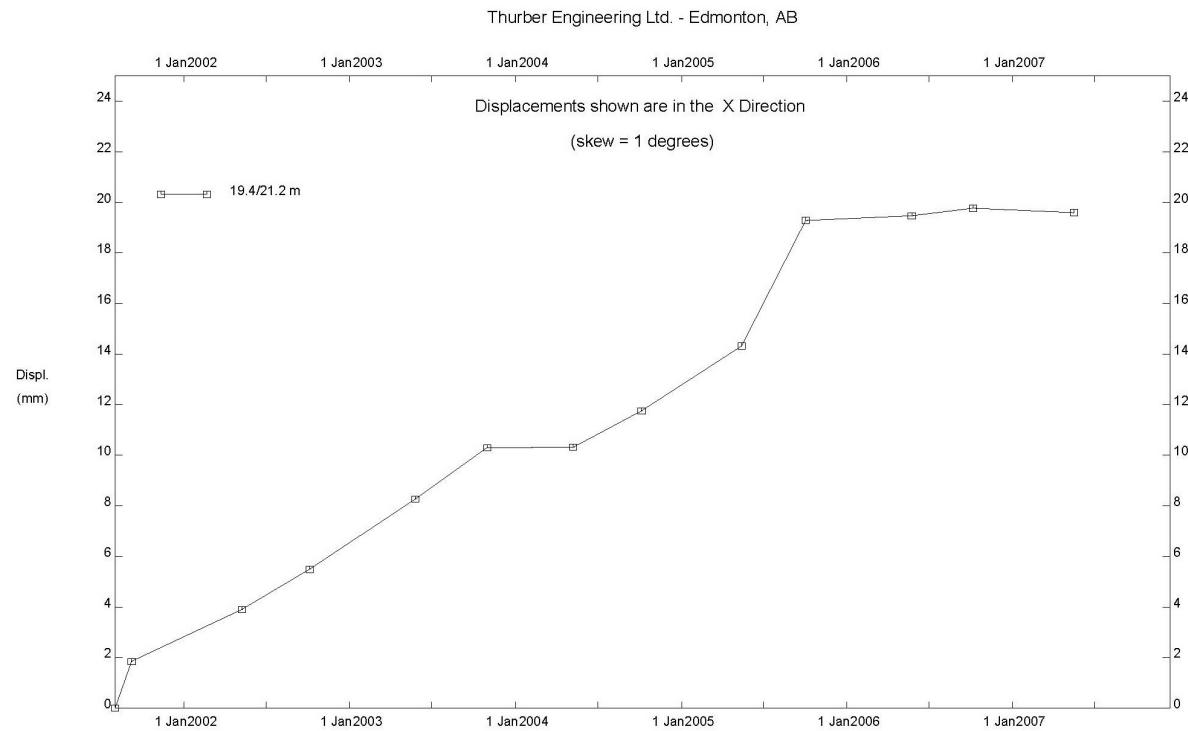
same slope inclinometer. The rate plot shows that the slope movement measured in this SI prior to construction of the subhorizontal drains was approximately 13 mm/year, and dropped to near zero over the next three sets of SI readings following the implementation of the remediation measures. This result is typical of the slope inclinometer results obtained.

Figure 9. Typical slope inclinometer (SI01-4) rate of movement plot
