PÉRIBONKA SPILLWAY ROCK CUT – ROCK FALL SIMULATIONS AND HAZARD PROTECTION MEASURES

Marco Quirion

1. INTRODUCTION

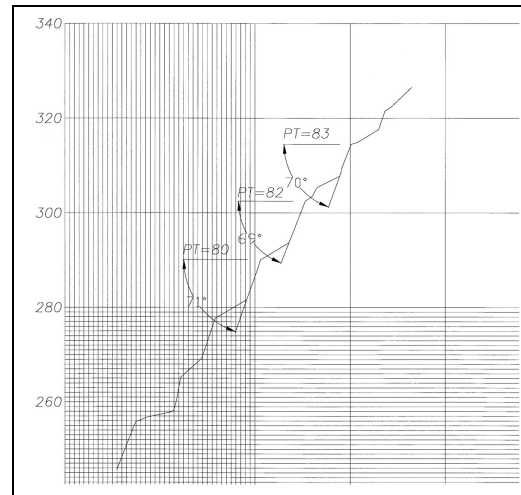
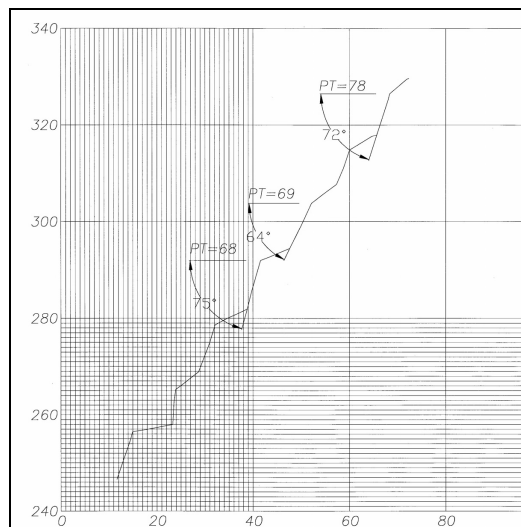
Figure 6. Resulting profile of the spillway right bank; a) at Chainage 260 and b) at Chainage 230.

Upon completion of the excavation, the final profile of the excavation was not as designed. Figures 6a and 6b show the resulting section of the slope face, at Chainage 260 and 230 respectively, from el. 245 to el. 320 approx. It can be seen that the 6 m wide berms are almost inexistent at many benches, or that the sharp crests were

If a block detaches from the top of the slope, the limited and variable width of the benches would allow the block to increase its speed while falling, and possibly fall into the access road and spillway. However, it has to be mentioned that no significant rock falls have occurred to date but, if nothing was done, it was expected that falls may occur in the future, particularly in the spring when the ice thaws and releases blocks loosened by the ice.

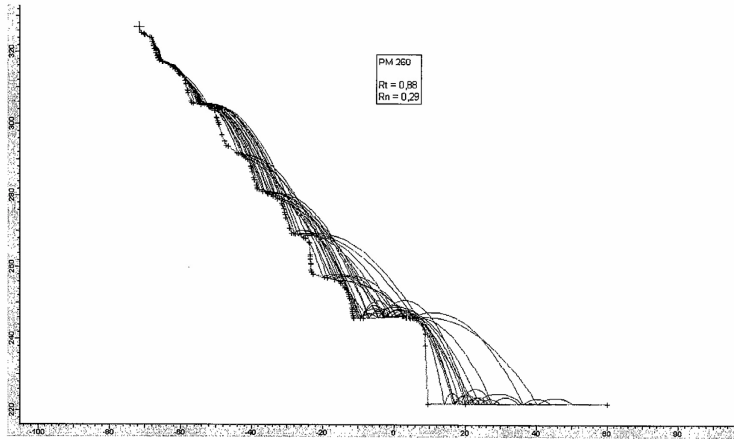
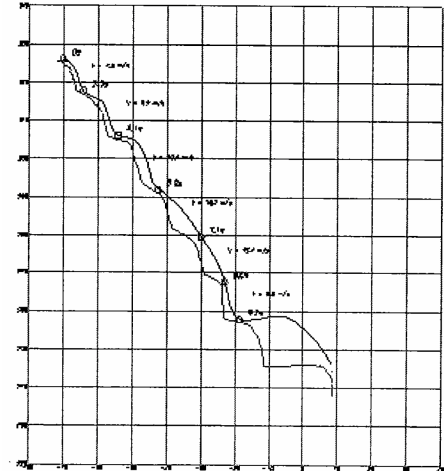
Figure 8. Block trajectories from a) rock fall simulation and b) in situ testing

Figures 8a and 8b are presented side-by-side to compare the trajectories, at Chainage 260, resulting from a rock fall simulation (values of 0,88 and 0,29 for Rt and Rn respectively) and the surveyed trajectory of rock block #8A having a volume of approximately 1,6 m³ and a weight of over 4 metric tons.

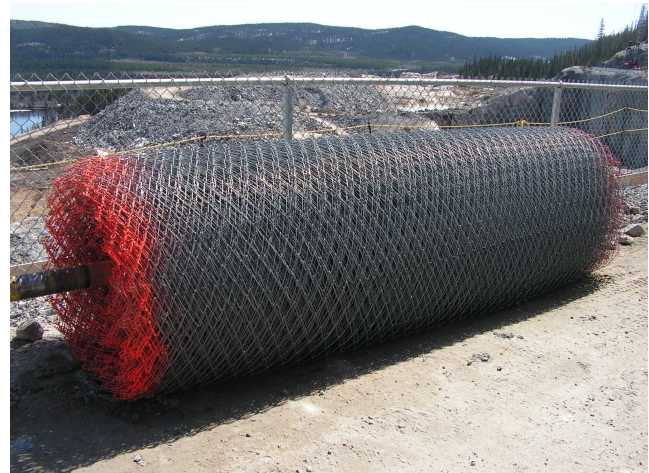
Figure 9 High strength mesh roll to be installed

High strength draped mesh was installed over most of the slope to protect both the spillway construction and access road. Mesh sections of 30 m long by 3,5 m wide (105 m²) as seen in Figure 9 were installed by Hydro-Quebec Construction team by following precise installation

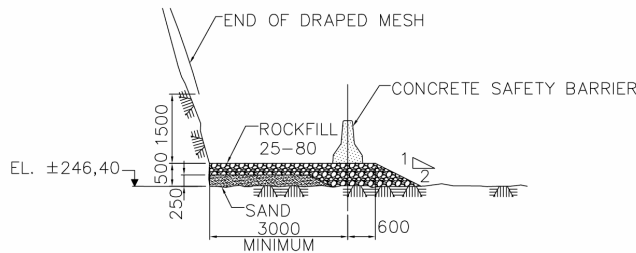
Figure 11. Catchments ditch at the toe of the slope

The draped mesh is used in combination with a catchment ditch located at the toe of the slope (Figure 11). As shown on Figure 11, the ditch includes a concrete safety barrier

located few meters away from the rock face with sand and rockfill material placed as cushion material.

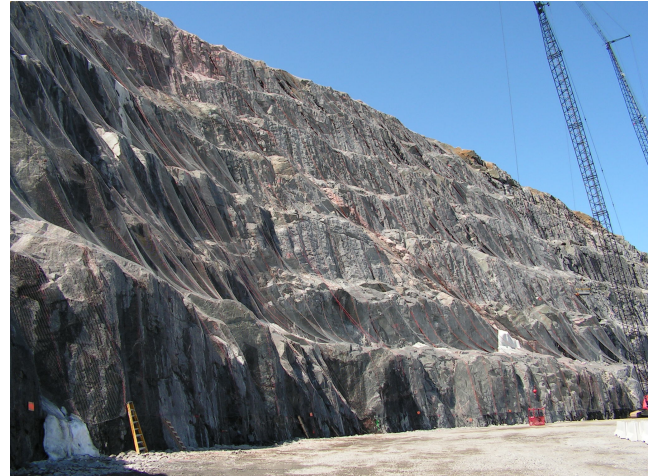
Figure 12. Mesh installation with crane on the slope face

Careful observation of the condition of the installed mesh (Figure 12) were to be required during construction of the spillway and repairs carried as necessary, which may include stabilization of the rock slope behind the mesh. If the mesh performs satisfactorily, it may become the long-term protection system for the slope.
