IGNORING ENGINEERING GEOLOGY A COSTLY MISTAKE AT PENTALIA, CYPRUS

Kyriakou E.

Hadjigeorgiou J.

The south west area of Cyprus has a long history of slope instability, particularly in areas of high elevation. This paper presents a case study whereby a new road was constructed in 2002 to link the villages of Nata, Pentalia and Panayia. The laying out of the road, however, ignored the engineering geology of the area. This omission has been costly, resulting in a segment of the road being subject to recurrent localized failures. The timeline of these instabilities is presented. After exploring several stabilization options the decision was finally made to move the road.

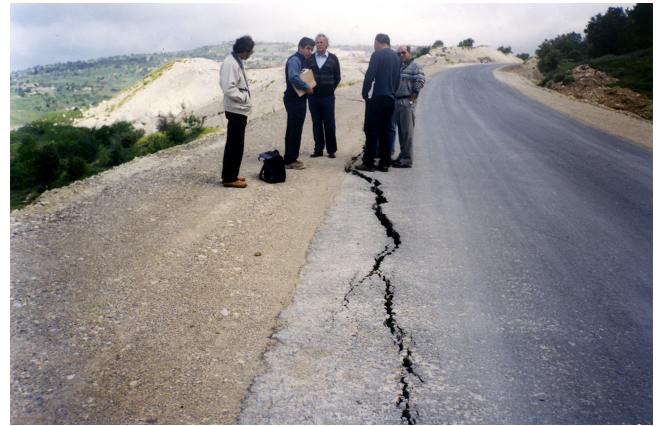
The road linking the villages of Nata, Pentalia and Panayia (along P453-P513) had already displayed signs of instability in January 2002 while the road was still under construction. The development of long cracks in the road, illustrated in Figures 6 and 7 was a cause of concern. The consensus was that these were linked to higher than usual rainfalls and snowfalls during December 2001. Following some remedial measures the road was completed and opened to traffic.

Figure 6. Initial signs of instability, January 2002.

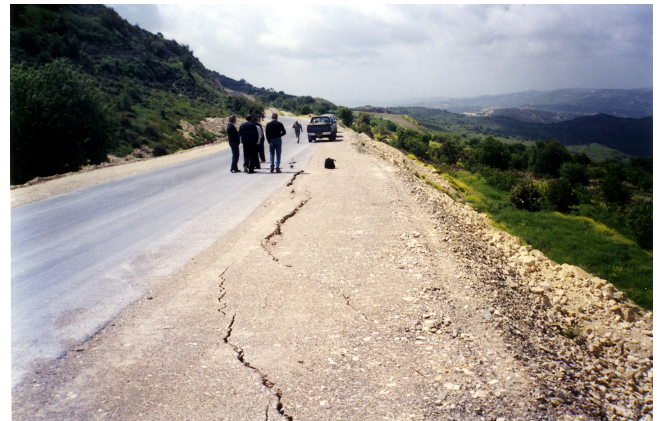
Figure 7. Initial signs of instability, January 2002.

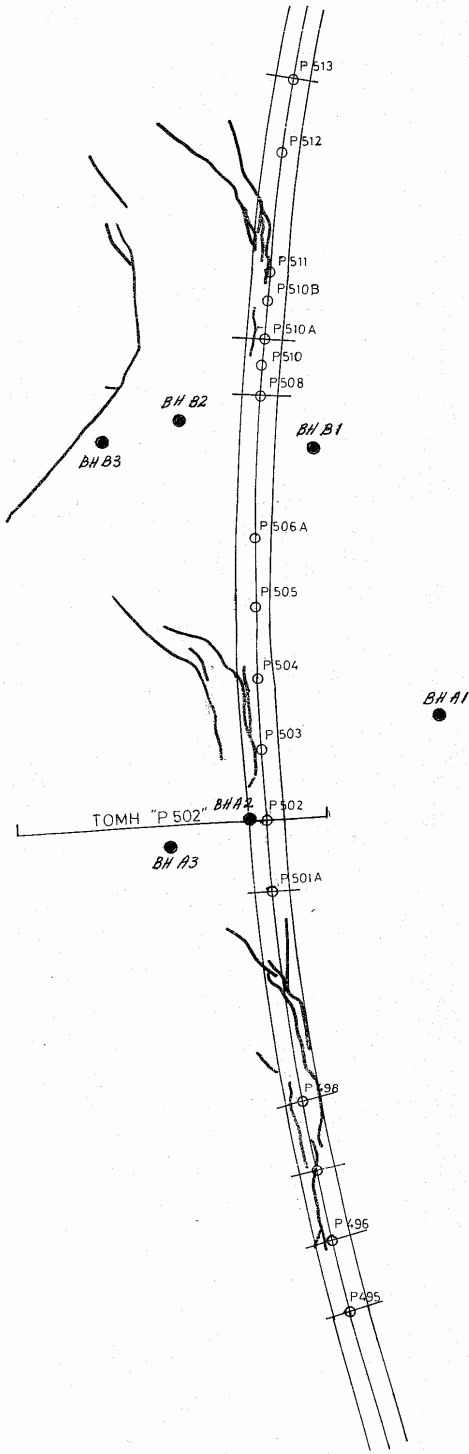
It was not long after completion of the highway that several new sets of cracks appeared on the surface of the asphalt. It was suggested that the slip surface was in the argillaceous substratum below the road and talus. By April 2003 it was decided to record these localized cracks (Figure 8 from Kyriakou 2003). These extended a long stretch of the highway as well as in the embankment. As shown in Figures 9 and 10 these cracks were long and quite deep cutting through the asphalt and substrata layers. Figure 11 illustrates the development of a major crack in the embankment of the highway.

Figure 8. Recorded fissures along the highway, Scale 1: 1000, April 2003.

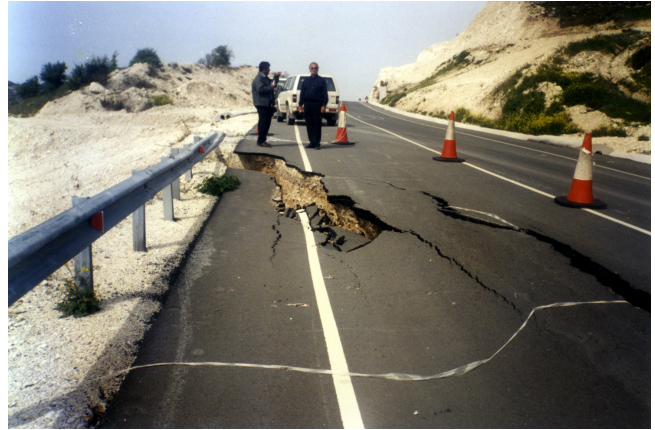
Figure 9. Signs of instability, April 2003.

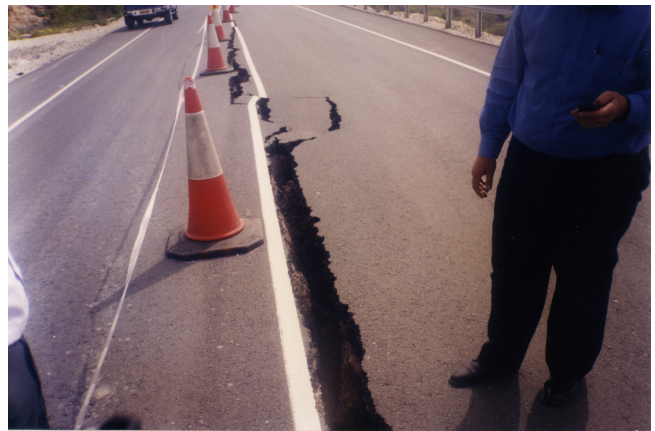
Figure 10. Signs of instability, April 2003.

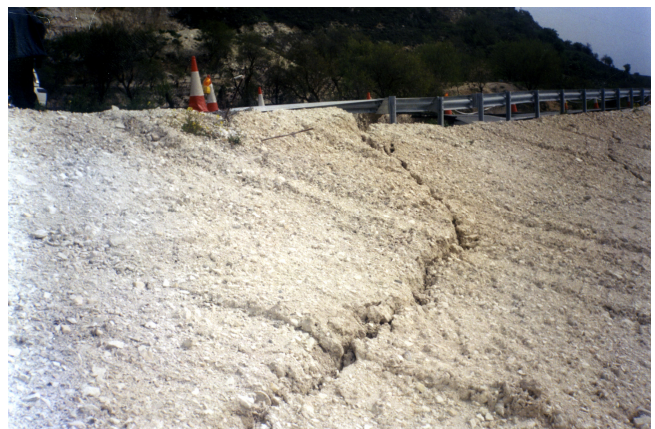
Figure 11. Signs of instability, April 2003.

Given that damage to the highway was over 300 m long, and the fact that this is a rural area, it was not possible to justify major stabilization works. Instead, it was decided that a stabilizing toe, associated with improved drainage, may provide a satisfactory option. Preliminary limit equilibrium analysis suggested that the use of a stabilizing toe may have been adequate for the assumed shallow failure.

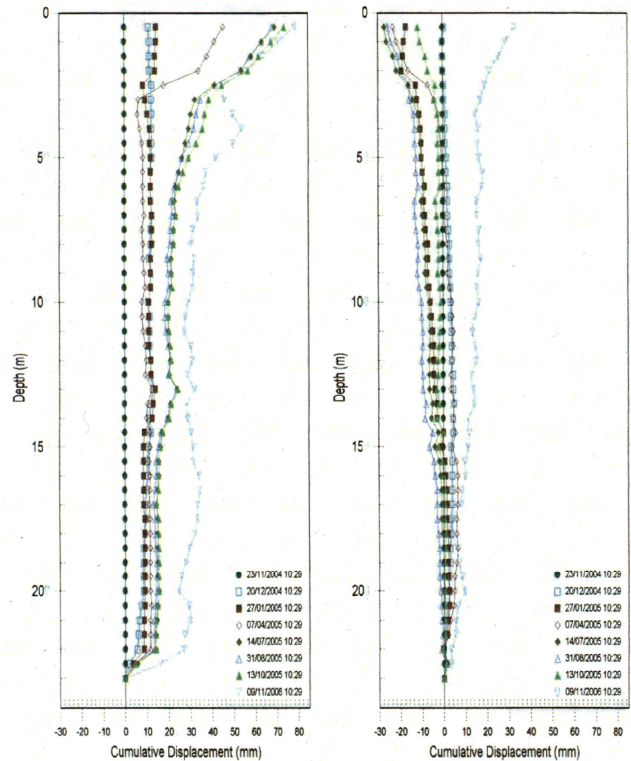
In order to determine the slip surface of the landslide four inclinometers were installed in boreholes A2, A3, B1 and B2. Figure 13 provides some of the early readings for borehole A3. Unfortunately the B2 inclinometer was broken at 3.20 m from ground surface, probably due to major displacement. In retrospect it might have been advantageous to locate the inclinometers at different locations along the length of the highway that showed signs of instability.

Figure 13. Displacement measurements in borehole A3, initial survey Nov. 23 2004 and final reading Nov. 9 2006.

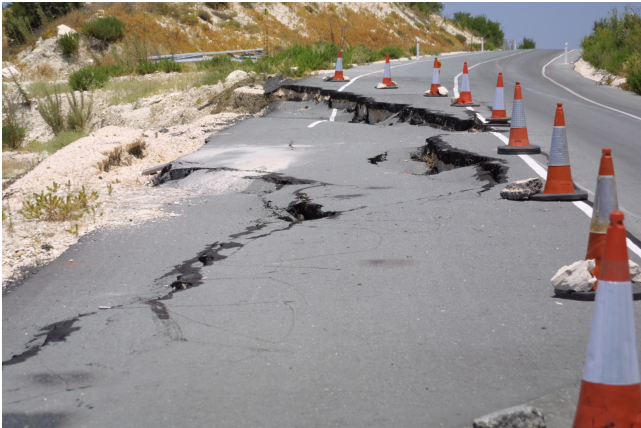
It should be recalled that the first signs of instability were reported during construction of the highway in January 2002. Although some more data were collected in fact no effective remedial action was taken other than “filling” the cracks in the asphalt. By the summer of 2005 the situation had deteriorated considerably as shown in Figures 14 and 15 resulting in more areas of instability.

Figure 14. Deterioration of the highway, 2005.

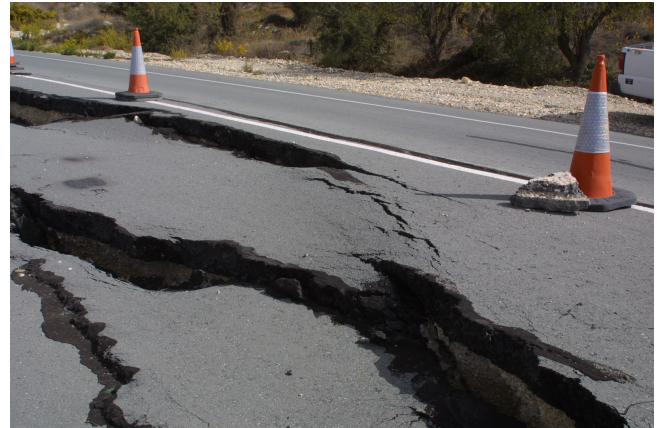
Figure 17. Widening cracks, November 2006.

In the meantime the situation continued to deteriorate to the level where a horseshoe potential failure surface was identified, Figure 16. It would appear that the cracks in the highway could be extended to old landslide scarps. Furthermore, the highway was unraveling and the cracks opening up further, Figure 17.

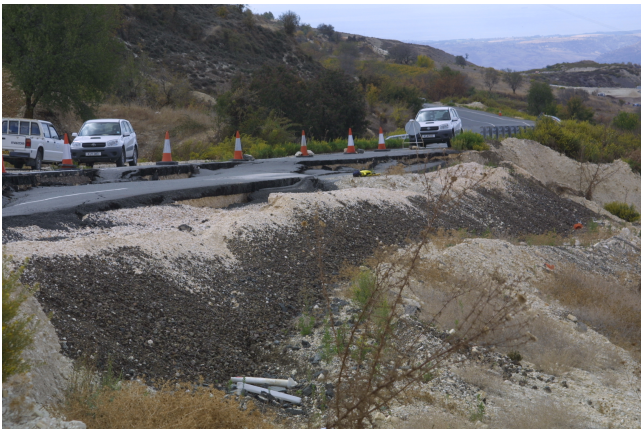
Figure 15. Deterioration of the highway, 2005.

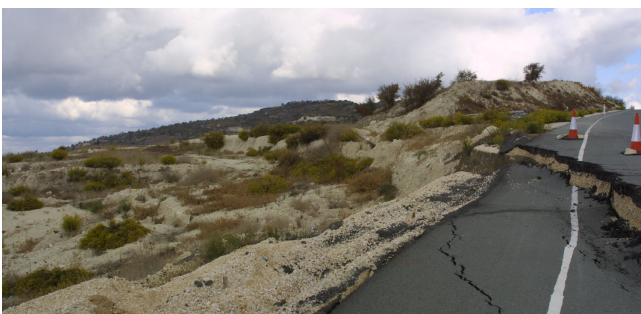
Figure 16. Horseshoe failure.

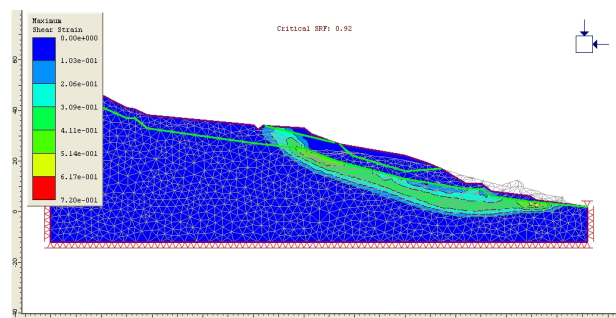
The same geometrical models used in the limit equilibrium analysis in Slide were introduced into the Phase2 finite element analysis package. An example is illustrated in Figure 18 where the maximum shear strain was determined. The strength reduction factor technique was also used to visualize the progression of failure within the slope. The zone of failure was visualised by plotting a total displacement graph. Figure 19 plots the total displacement concentrations and the resulting deformed mesh. The resulting slope geometry closely resembled the observed field conditions.

Figure 18. Section B-B illustrating the development of maximum shear strain concentrations.

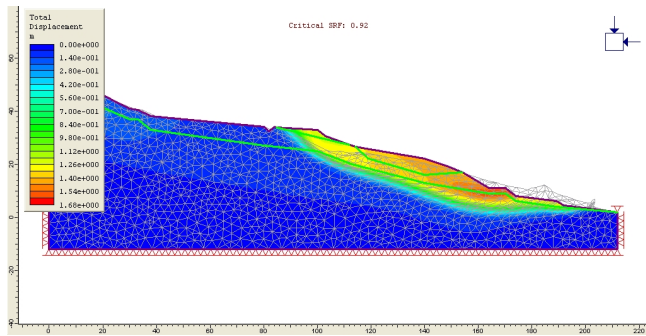
Figure 19. Section B-B deep failure illustrating the development of total displacement concentrations.

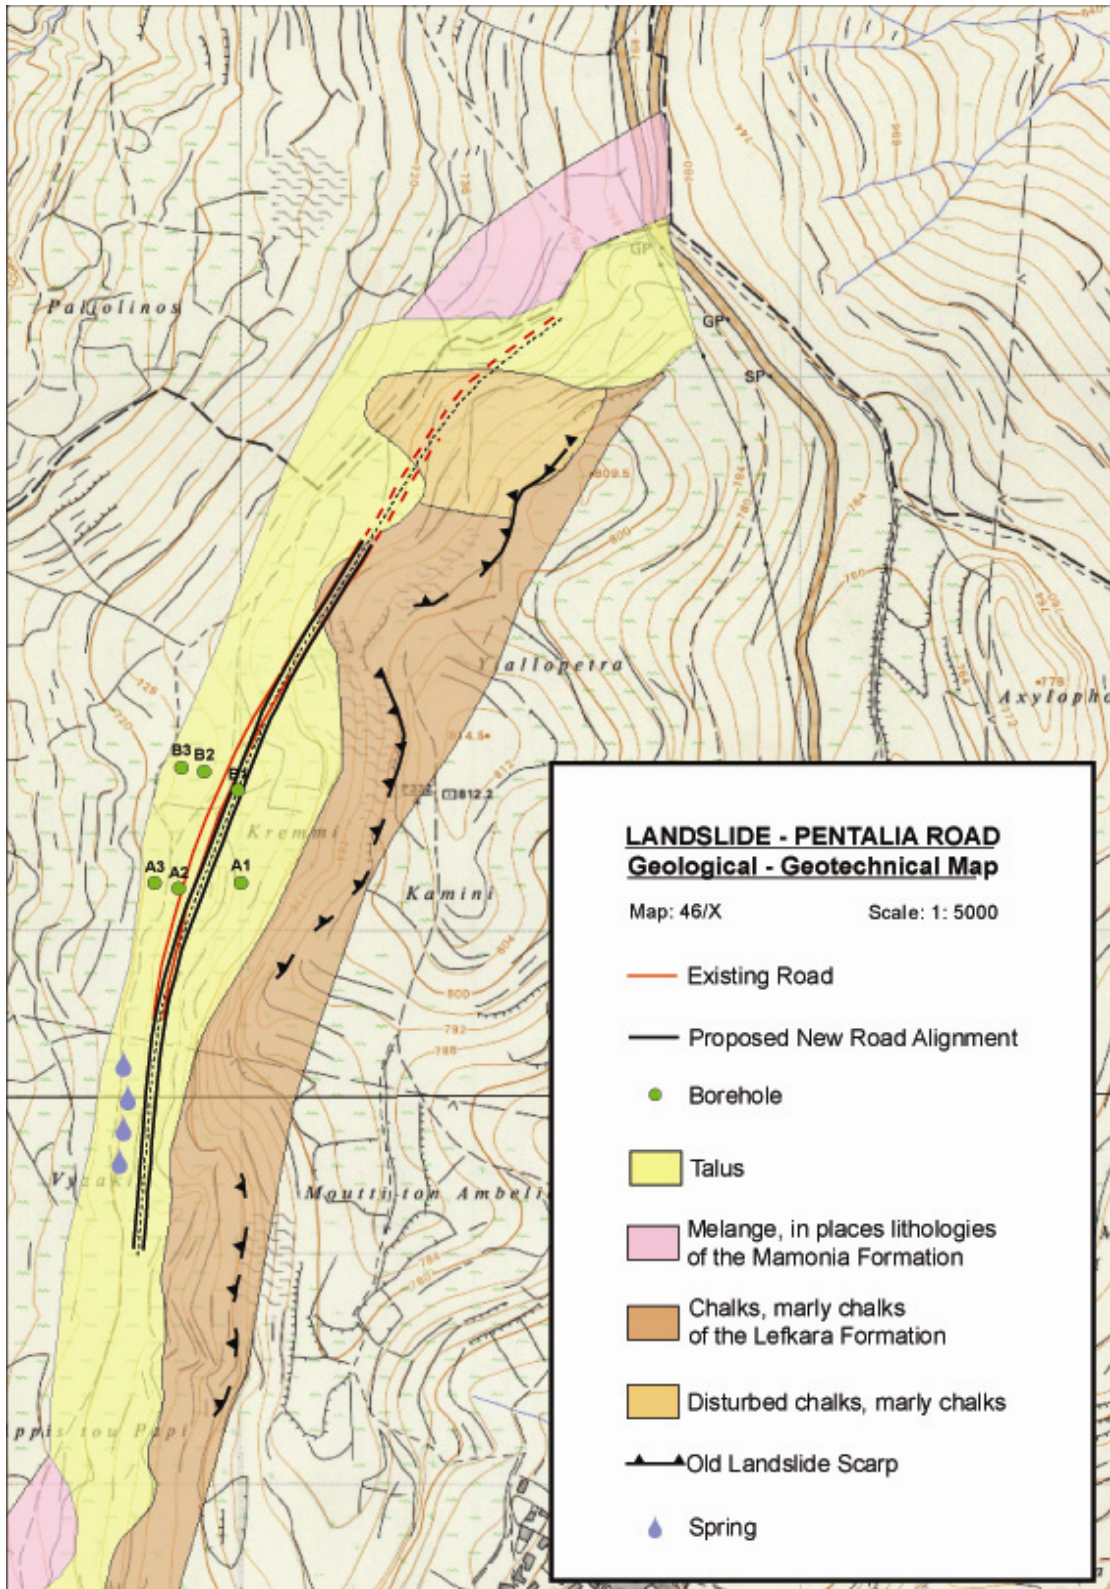
The construction of a new road, as the finally adapted solution, has not yet began, although the construction designs are now completed. Figure 20 provides a summary of the available information for the stretch of instability of the Pentalia highway. It shows the existing highway as well as the surficial deposits of talus and melange. The overhanging chalks over the highway are also noted.

The location of boreholes A1, A2 and A3 as well as B1, B2 and B3 are also identified. Of interest however are the signs of all landslide escarpments in the chalks and the location of seasonal springs just below the highway in the talus.

Figure 20. Geological-geotechnical map identifying the geology, old landslide scarps, the boreholes and the existing and new road alignment.

The new road alignment, several meters from the existing road, is also shown in Figure 20. The new alignment is well outside the zone of cracks and settlements that were noted on the existing road. Nevertheless, it is still within an area of past instability, and is still in the same geological conditions. The rationale of the transportation engineers is that the existing road embankment may act as a stabilizing agent. This was not however demonstrated by further analysis. The new works also involve a well designed and effective drainage system along the road. Up the road there will be a diversion channel to reroute surface water away from the road. Whether this shifting of the road, even with improved drainage measures will be sufficient to avoid future instability remains to be seen.
