# LANDSLIDE HAZARDS AND THEIR MITIGATION ALONG THE SEA TO SKY CORRIDOR, BRITISH COLUMBIA

Andrée Blais-Stevens

Oldrich Hungr

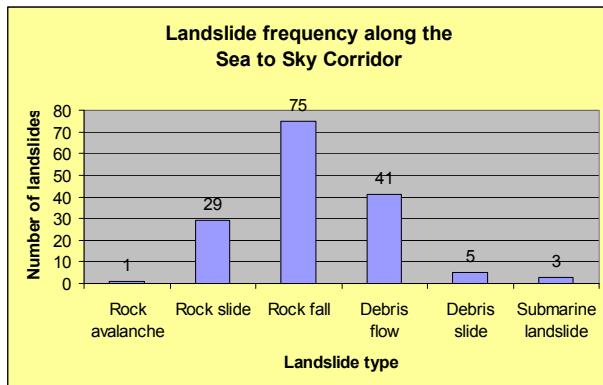
Figure 3. Number of landslides compiled from 1855-56 to 2007 divided by type.

important to note that in the southern part of the corridor, the highway is just metres away from very steep bedrock slopes unlike in the northern part of the highway where the valley is wider; thus, creating greater chances of slope failures reaching the highway and settlements than if farther away. The most abundant types of landslides have been rock falls and debris flows (Figures 2a, b, and 3). For about two thirds of these landslide events, the trigger/cause, when reported, was identified as either climate (54%) or construction (6%; Blais-Stevens, 2007; Blais-Stevens and Septer, 2008).

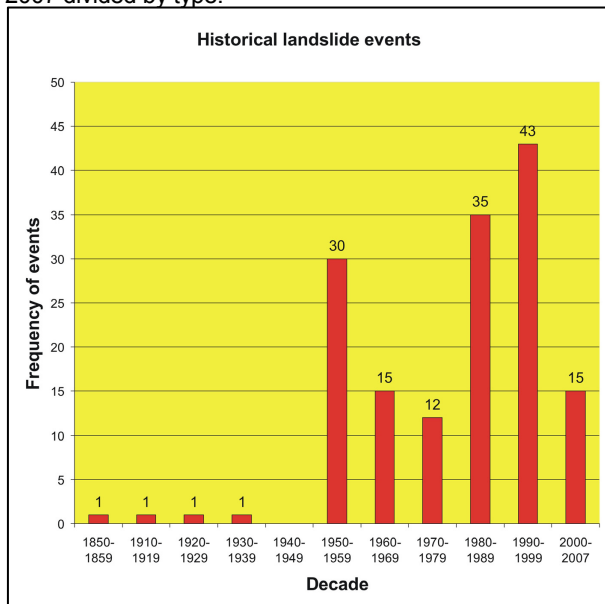
Figure 4. Number of reported landslide events per decade, from 1855-56 to 2007.

A histogram showing the frequency of historical events per decade (Figure 4) indicates that the number of events showed a dramatic increase on the 1950s (30 events). This likely is related to the construction associated with the opening of the southern extension of the Pacific Great Eastern railway (now owned by CN Rail) between Horseshoe Bay and Squamish in 1956 (Blais-Stevens and Septer, 2008). The 1980's (35 events) and 1990's (43 events) saw a peak in number of events. This is most likely due to a greater increase in development of the corridor, *i.e.*, more people, more infrastructure development, more awareness of landslide hazard, thus more reporting. Furthermore, most mitigation measures (*e.g.*, such as

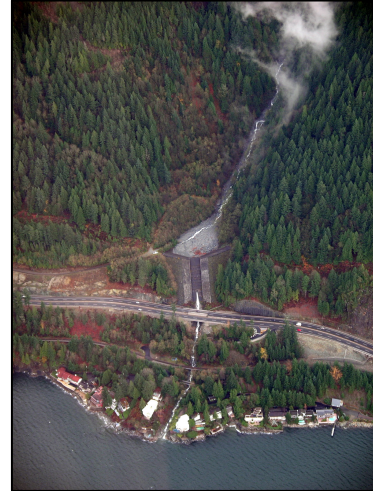
Figure 5. Charles Creek debris basin at work. Notice the debris basin is stopping the debris flow deposit and protecting the Sea to Sky Highway, railway, and homes built on the alluvial fan.

As a consequence, a catchment basin was built at this high gradient creek as well. Thus, in November 2006, a debris flow of 20,000 m<sup>3</sup>, which could have affected the highway, the railway, and the homes built on the fan of Charles Creek, was controlled by the debris basin (Figure 5). What could have been a disastrous event at Charles Creek did

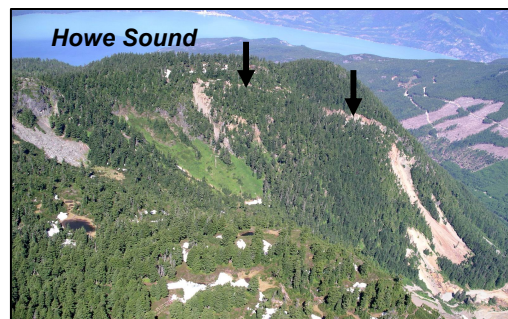
Figure 6. Subsiding rock wall at Jane Creek (arrows indicate major tension crack), east of Britannia Beach. Picture taken from the head scarp area of the 1915 catastrophic landslide site mentioned above.

One of the present concerns is the Britannia Creek basin. Subsidence and tension cracks caused by underground mining in mid-1900's are apparent along the opposite wall of the where the 1915 Jane Camp rockslide took place (Figure 6), involving a rock volume in the order of 20 million m<sup>3</sup>. Preliminary observations by several specialists, including the second author, indicate that the heavily fractured volcaniclastic bedrock could fail catastrophically. However, more detailed research and monitoring are needed to confirm the hazard. If there is potential for slope failure, Britannia Beach, which is a town under expansion, and the Sea to Sky Highway could be at risk.

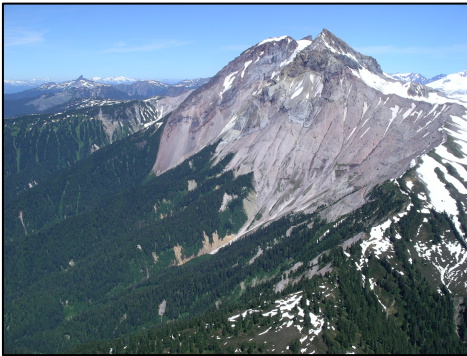
Figure 7. The headwall of Cheekye River valley. Scars of large rock slides can be recognized on the slopes. The interface between Quaternary volcanic rocks and the metamorphic basement coincides approximately with the tree line.

Mount Garibaldi is a 2600 m Quaternary volcano situated at the head of Howe Sound, north-east of the town of Squamish (Figure 2a). A large part of the present stratovolcanic edifice was built by mixed explosive and effusive activity in contact with ice, during the final stages of Pleistocene glaciation (Matthews, 1958). During and following the retreat of ice, the valley of the Cheekye River deeply incised the volcano and the underlying metamorphic basement. At present, the drainage of the Cheekye River is about 10 km long, with a vertical relief of more than 2.5 km. It culminates in a 1.5 km near-vertical headwall, cut in altered and weak metamorphic basement rocks, capped by a complex assemblage of unwelded volcanic breccias and dacitic lava flows (Figure 7).

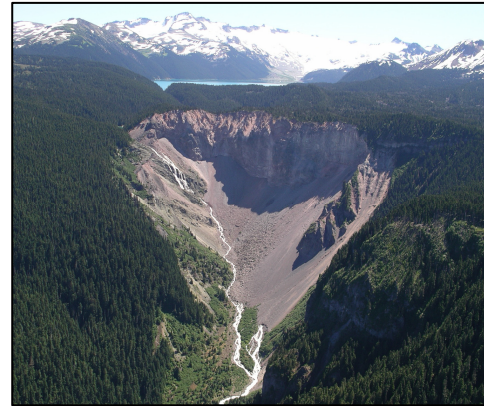
Figure 8. The Barrier, a lava cliff at the head of Rubble Creek drainage and source of the 1855-56 rock avalanche that reached the Squamish-Whistler corridor.

The second recognized hazard source related to the Garibaldi volcanic centre is the valley of Rubble Creek, half-way between Squamish and Whistler. Here, the corridor crosses the deposits of the 1855-56 rock avalanche (Moore and Matthews, 1978). Its source is the Barrier, a 500 m high cliff created by damming of basaltic lava flows against retreating Pleistocene ice, filling the

Cheakamus Valley. (Figure 8) The history of the Rubble Creek drainage also includes large debris flows, which likely originated by major overflows of Barrier Lake, sending catastrophic discharges down the creek channel and re-mobilizing talus and rock avalanche deposits in the valley. Again, important development restrictions exist within the corridor on account of potential renewal of landslide activity in the valley.
