THAW SETTLEMENT OF DEGRADING PERMAFROST: A GEOHAZARD AFFECTING THE PERFORMANCE OF MAN-MADE INFRASTRUCTURES AT UMIUJAQ IN NUNAVIK (QUÉBEC)

Richard Fortier, ing., Ph.D.

Maxime Bolduc, ing. jr.

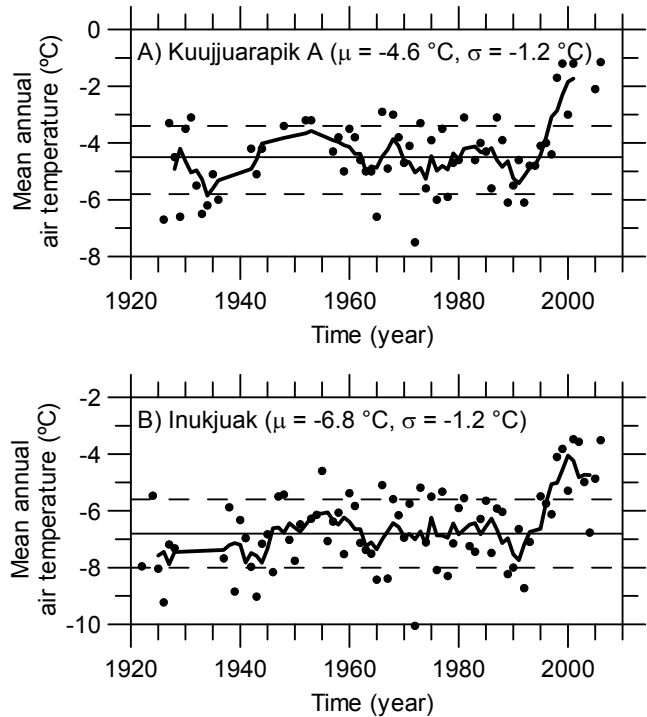
Figure 2: Mean annual air temperature at Kuujjuarapik (B) and Inukjuak (C). Meteorological data from Environment Canada. The broken lines correspond to a 5-year running average. Full and dotted horizontal lines are respectively the average and \pm standard deviation (values in parentheses) over the reference period 1961-1990.

Meteorological data are available for the Inuit communities of Kuujjuarapik and Inukjuak (Figs. 1 and 2). A marked trend to climate warming of at least 3 °C is observed since 1992. The mean annual air temperature is well above the average air temperature found for the reference period 1961-1990 plus one standard deviation since 1998 except for 2004.

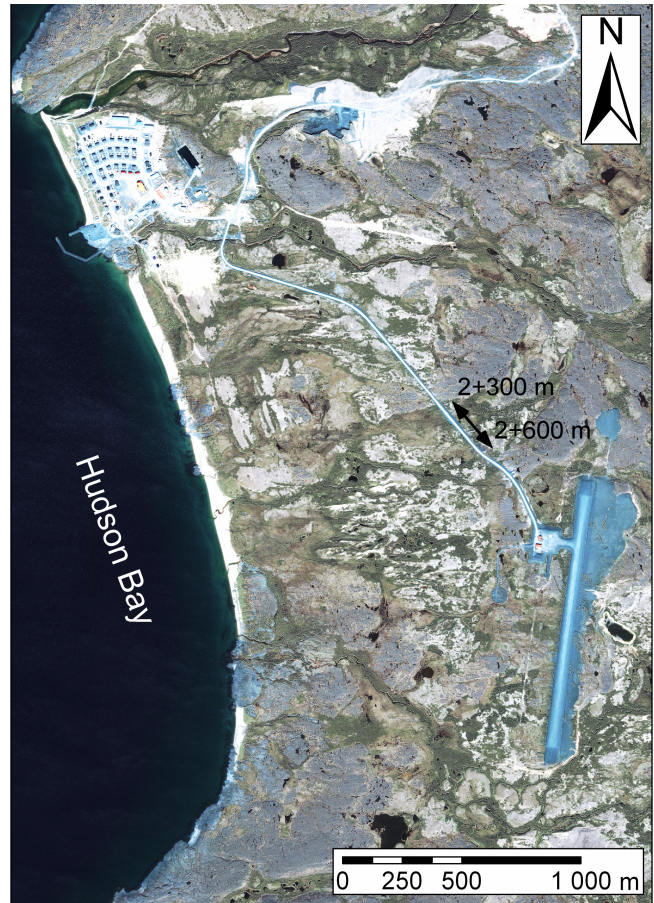
Figure 3: Inuit community of Umiujaq. The ends of the 300-meter long road segment affected by thaw subsidence are identified according to the location system of the Ministère des Transports du Québec (1991).

Situated on the east coast of the Hudson Bay, Umiujaq is a small Inuit community of about 300 people (Figs. 1 and 3). It is located in the discontinuous permafrost zone (Fig. 1). While most village infrastructures are built on raised sandy beaches, a thaw stable material, other major infrastructures such as roads and the airfield lie in part on frozen ice-rich marine sediments, a thaw instable material, outcropping or buried underneath a sand veneer. The road leading to the airport built in 1991 is a good example of an infrastructure affected by permafrost degradation mainly under the form of localized zones of thaw subsidence (Fig. 4). A 300-meter long road segment lying on a sand cover in a depression between two rock outcrops was studied in 2006 (Fig. 3). At the distance 2+430 m, two culverts one over the other across the road embankment concentrate the runoff water flowing to the west along the gentle slope of the seaward-dipping bedrock.

Ground penetrating radar (GPR) surveys were carried out in July 2006 along two 300-meter long segments over the road and in the field 10 m away from the west shoulder of the road embankment (Fig. 3) to assess the ground stratigraphy underneath the road embankment and in the field. The GPR used was a pulseEKKO 100 from Sensors & Software inc. with antennas of 50 and 100 MHz for the road and field investigation respectively. The lowest frequency was used for a deep penetration across the thick embankment and in the underlying ground. Two types of GPR survey were employed: 1) fixed-offset reflection profile and 2) common mid-point sounding (CMP sounding).

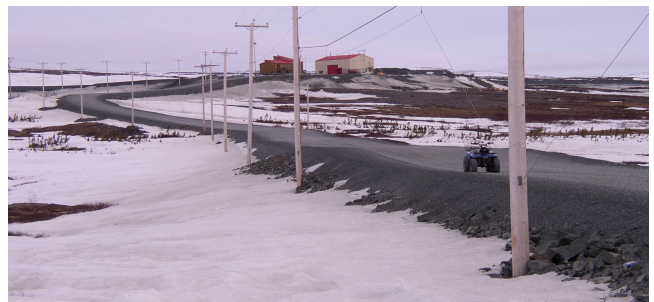
Figure 4: South view of the localized zones of thaw subsidence along the access road to the airport of Umiujaq. The all-terrain vehicle is located in one zone of thaw subsidence. Note the snow accumulation on each side of the road embankment. The photograph was taken in April 30th 2007. The snow cover was already degrading following the spring warming.

The subsidence observed along the access road to the airport of Umiujaq took place in the clay unit underneath the road embankment and sand layer. The thawing of permafrost between 1991 and 2006 induced a thaw consolidation and a decrease in void ratio of about 15% (subsidence of 0.63 m over a 4-meter thick unfrozen layer). Contrary to the initial design of a thick road embankment, the freeze-thaw cycles reach now the underlying ground. Moreover, the thick road embankment disrupts the gentle topography and acts as a barrier favoring the snow accumulation. The thawing of permafrost is therefore not only due to the recent climate warming trend observed in Nunavik (Fig. 2) but also the snow accumulation along the embankment shoulders which insulates the ground surface in winter and prevents further ground freezing (Fig. 4).

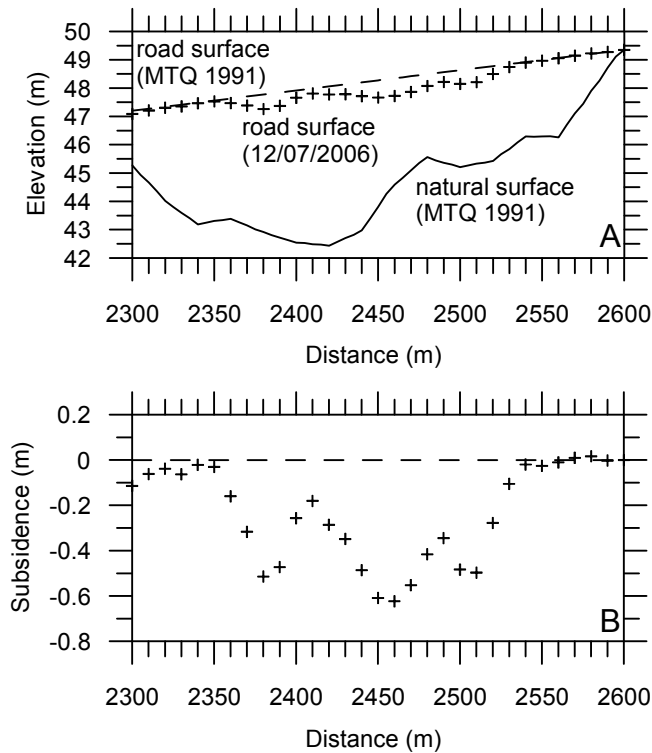
Figure 5: A) Elevation of the road surface and the natural surface in 1991 (dashed and full lines respectively), and the road surface in July 12th 2006 (+ symbols). B) Thaw subsidence of the road surface between 1991 and 2006.

The elevation of the road surface was measured in July 12th 2006 using an electronic level (Fig. 5A). The elevation measurement can be compared to the drawings as built of the airfield and access road of Umiujaq (Ministère des Transports du Québec 1991). The thaw subsidence, the difference in elevation between 2006 and 1991, can be as high as -0.63 m (Fig. 5B). The total volume of subsidence is close to 530 m³ for a road embankment 7.4 m wide. The embankment thickness is in excess of 5.6 m at 2+420 m for an average value of 3.6 m along the studied road segment.

Since the end of construction in 1991 to 2006, the surface subsided as much as 0.63 m along the studied road segment. This subsidence is due to the thaw settlement taking place in the underlying ground following the thawing of permafrost. However, without a good knowledge of the ground stratigraphy, the origin of this subsidence is not exactly known.

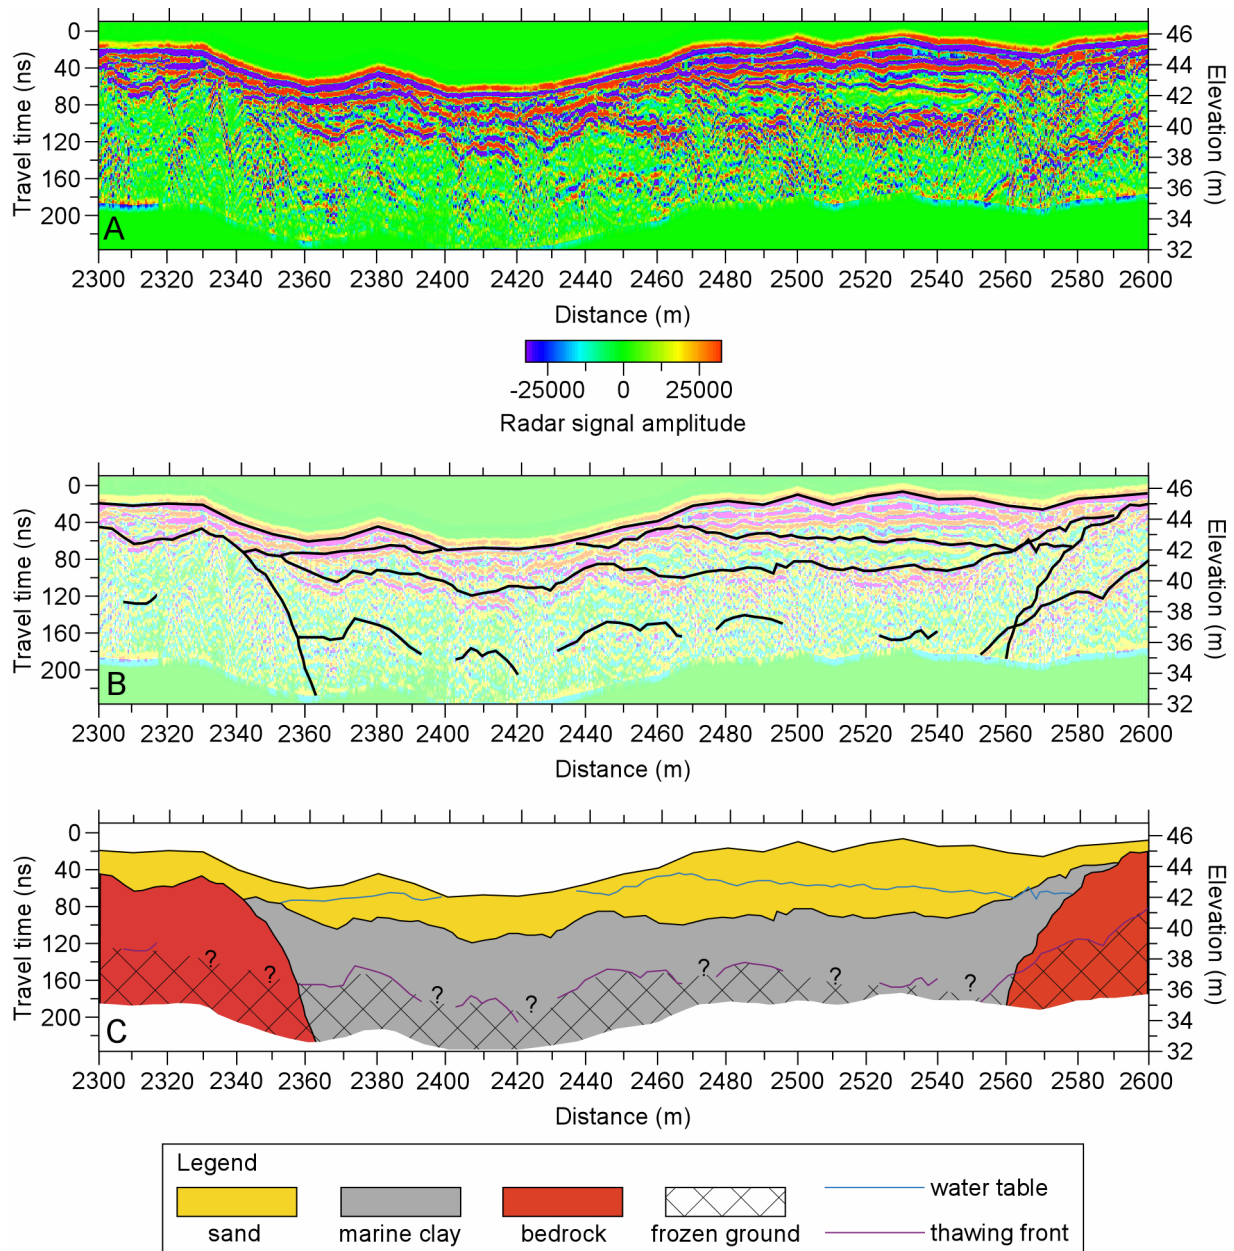
Figure 7: A) GPR reflection profile carried out in the field with antennas of 100 MHz at a fixed offset of 1 m. B) Major reflectors identified on the GPR reflection profile. C) Cross-section of the ground interpreted from the GPR reflection profile and model of electrical resistivity (Fig. 8C). Note the vertical exaggeration (1:4.4).

the field are given in figures 6 and 7 respectively. Major reflectors in the ground are identified in figures 6B and 7B.

To transform the travel time profile in a depth profile for assessing the depth of the reflectors, the velocity of the radar signal into the ground is needed. It can be estimated from a CMP sounding by varying the antenna spacing but keeping fixed the common mid point between the antennas. According to the CMP soundings carried out in the present study (results not shown), the radar signal velocity is about 0.12 m/ns; characteristic value for a moist sand. This value can be then used to produce depth profiles (Figs. 6 and 7).

The GPR and ERT are complementary geophysical methods for permafrost investigation. While a GPR reflection profile provides stratigraphic information at high resolution without identifying the soil layers (Figs. 6A and 7A), the ground conditions can be assessed from the ERT but the stratigraphic contacts are not accurately located in the model of electrical resistivity (Fig. 8C). The combined interpretation of the GPR reflection profile and ERT carried out in the field results in a cross-section of the ground (Fig. 7C). This cross-section in the field can be then used to help in the interpretation of the GPR reflection profile over
