PÉRIBONKA SPILLWAY ROCK CUT – ROCK FALL SIMULATIONS AND HAZARD PROTECTION MEASURES

Marco Quirion

1. INTRODUCTION

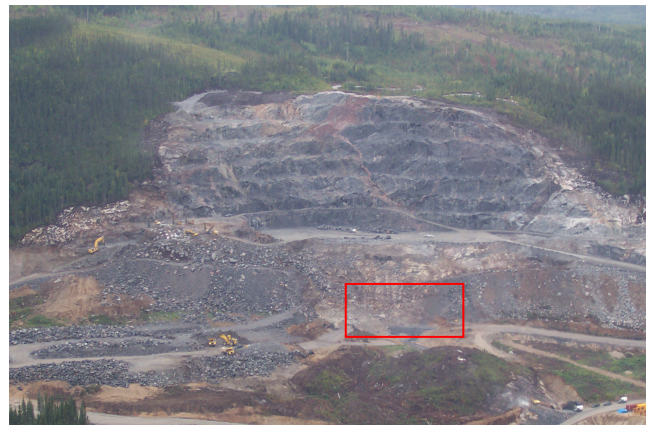
Figure 3. Péribonka spillway excavation. Spillway concrete structure zone in box.

The spillway is oriented NW-SE and is excavated in the steep hillside on the right bank of the Péribonka River. It should be mentioned that the spillway excavation section located above the reservoir level was planned to serve as a quarry to provide rock material for the construction of the main dam. The location of this large excavation is shown in Figures 2 and 3.

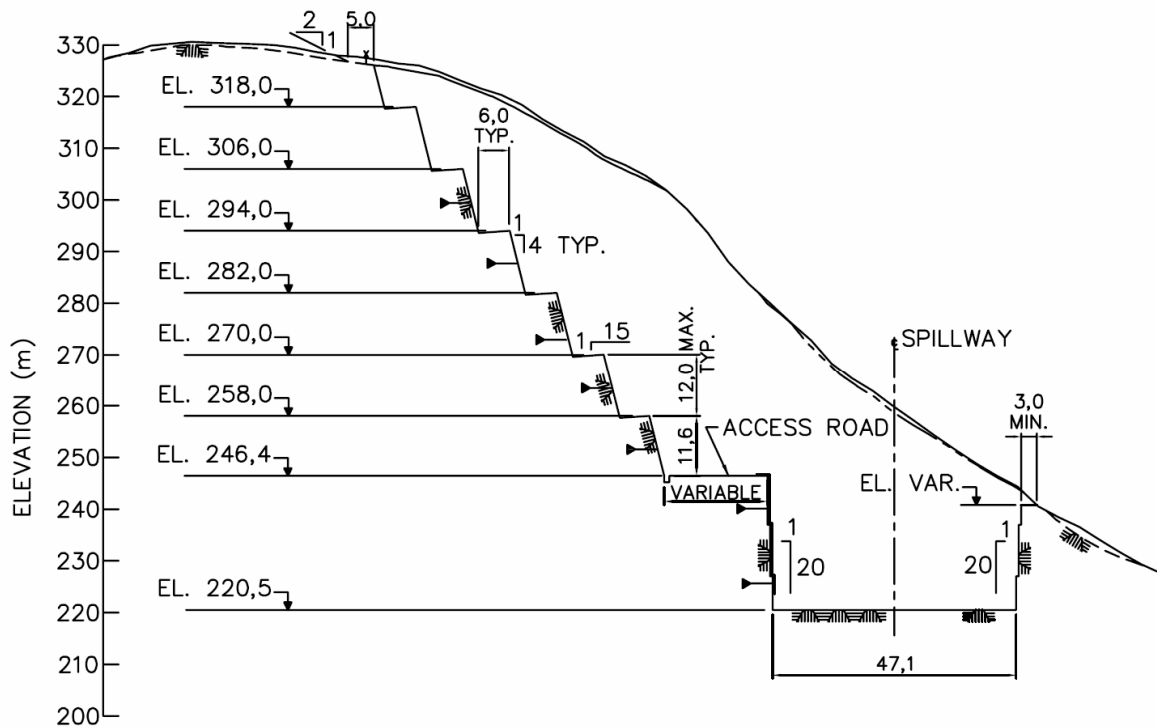
Figure 4. Typical cross-section of the spillway rock cut.

The typical cross-section of the selected option is shown in Figure 4. The volume of rock obtained with this configuration is in the order of 1 000 000 cubic meters. Figure 5 shows a 3-D representation of the benches with an indication of the location of sections at Chainages 230 and 260; simulation and in situ testing were conducted at these sections.

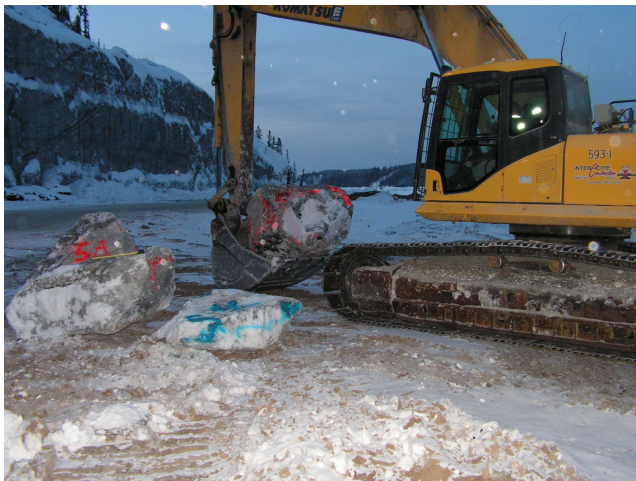
The rock fall tests involved gently nudging boulders off the crest of the cut on Sections 230 m and 260 m. The dimensions of the blocks were measured and their approximate diameter and weight were calculated; the blocks were approximately cubic shaped with sharp edges, rather than tabular or columnar. The blocks were classified according to their dimensions – Class A: 1.5 to 2 m³; Class B: 0.9 to 1.3 m³ and Class C: 0.45 to 0.76 m³. There were eight blocks in each class. Figure 7 shows a picture of few of the blocks.

Figure 7. Blocks selected for the in situ rolling rock test
The rock fall trajectories were observed as they crossed the road at the base of the cut; the locations of the last two impact points were surveyed. A film recording of each test was made with a digital camera, the high speed camera did not work as these tests were conducted during a cold winter day.
