IGNORING ENGINEERING GEOLOGY A COSTLY MISTAKE AT PENTALIA, CYPRUS

Kyriakou E.

Hadjigeorgiou J.

The south west area of Cyprus has a long history of slope instability, particularly in areas of high elevation. This paper presents a case study whereby a new road was constructed in 2002 to link the villages of Nata, Pentalia and Panayia. The laying out of the road, however, ignored the engineering geology of the area. This omission has been costly, resulting in a segment of the road being subject to recurrent localized failures. The timeline of these instabilities is presented. After exploring several stabilization options the decision was finally made to move the road.

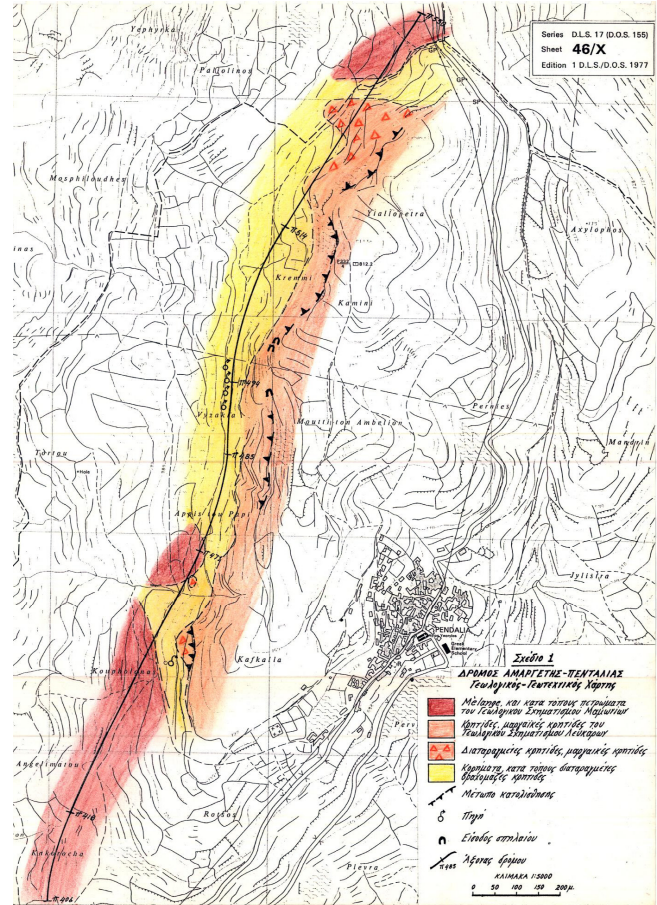
Figure 2. Geotechnical Map of the area.

Nevertheless, little attention was given to engineering geology. This was somewhat surprising given that Charalambous (1991) had provided a geological and geotechnical map of the area where she clearly identified areas of disturbed ground as well as landslide scarps (Figure 2). It would appear that this information was not taken into consideration when the highway was laid out.

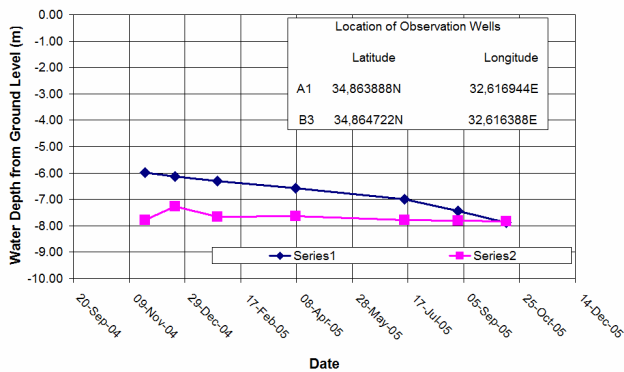
Figure 12. Observation wells.

Two piezometers were installed in boreholes A1 and B3. The recorded levels are shown in Figure 12. These confirmed the perception of a perched water table within the talus, overlying the impermeable *mélange*.

The level of the perched water table is controlled by the seasonal precipitation and can fluctuate considerably. In the same geological setting it is not unusual to note the presence of seasonal and temporary springs along the talus-*mélange* contact or within the highly weathered and disturbed *mélange*.
